VINSBROOK ESTATES DAM NO. 1  
WARREN COUNTY, MISSOURI  
AG. 31714

**PHASE 1 INSPECTION REPORT  
NATIONAL DAM SAFETY PROGRAM**

4. TITLE (and Subtitle) Phase I Dam Inspection Report National Dam Safety Program Innsbrook Estates Dam No. 1 (MO 31714) Warren County, Missouri		5. TYPE OF REPORT & PERIOD COVERED Final Report

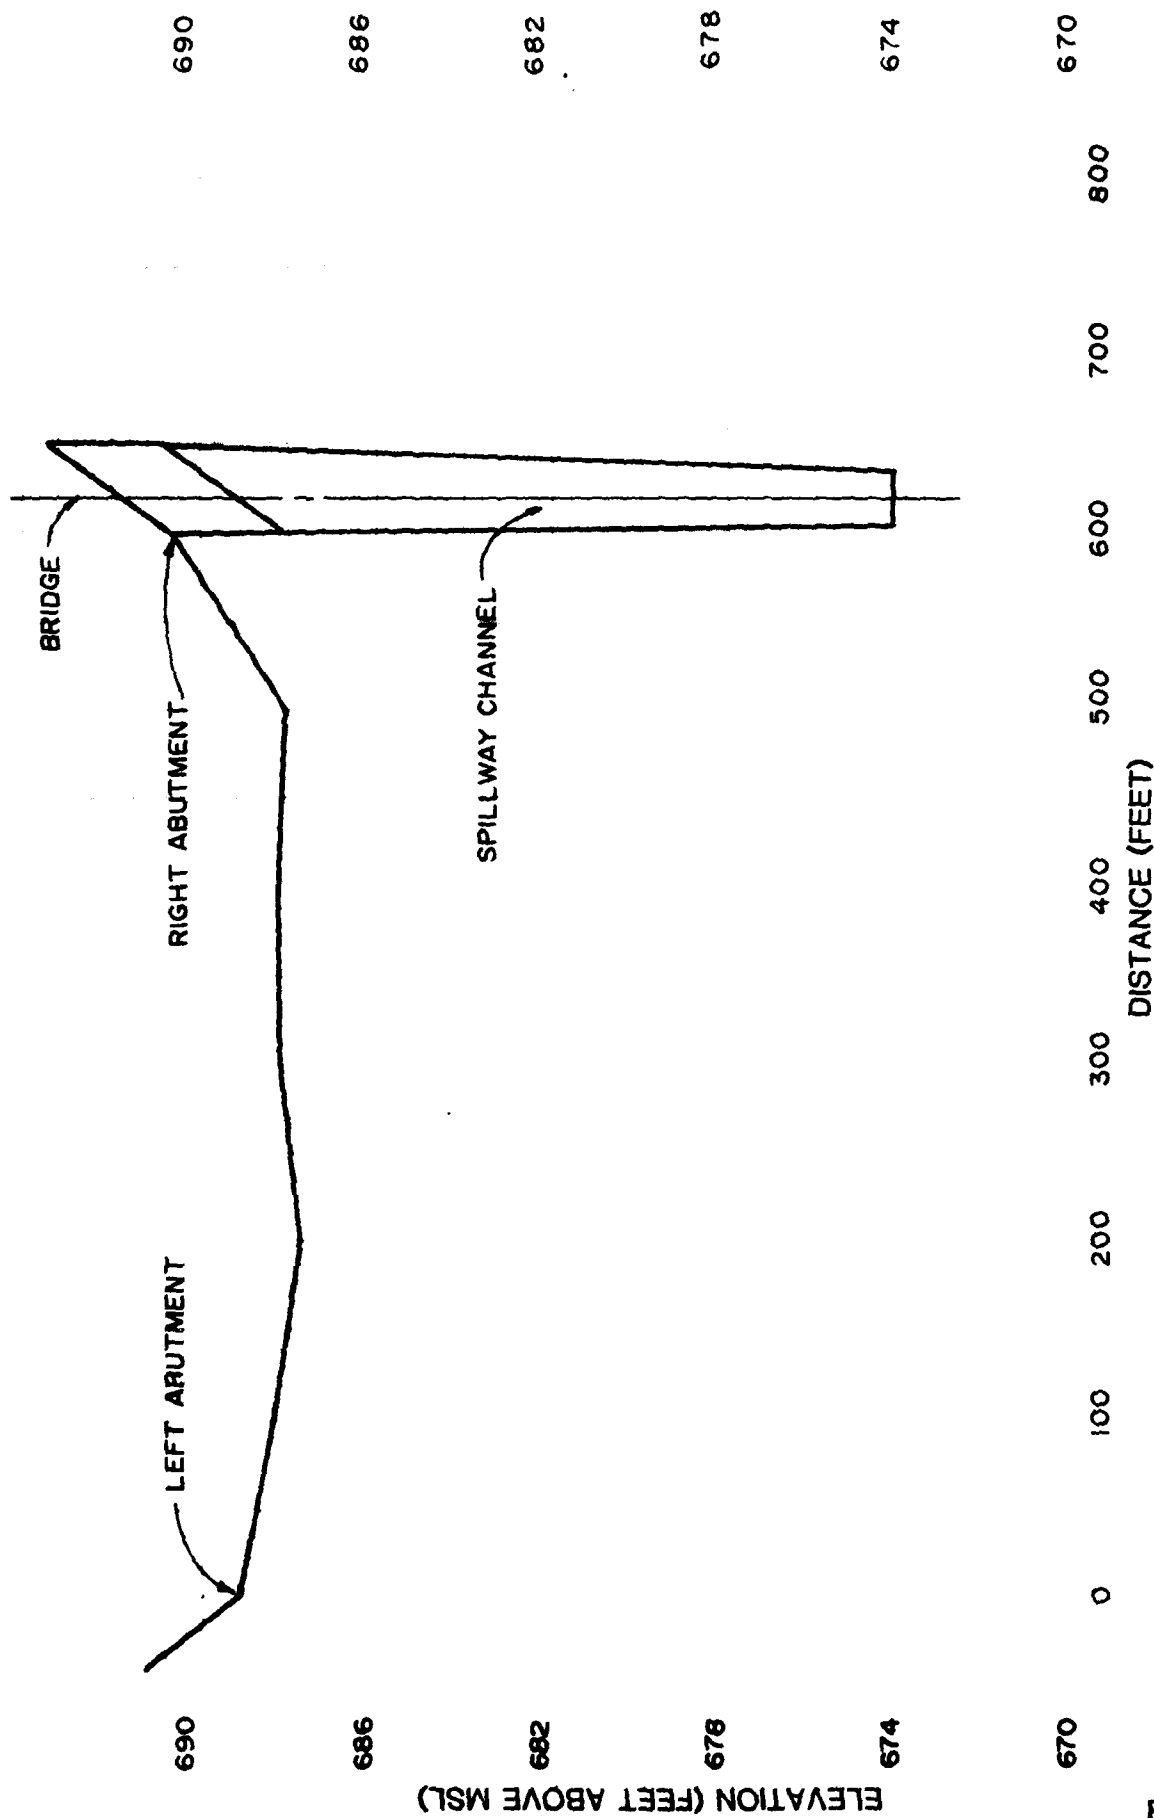
PROFILE OF DAM CREST  
INNSBROOK ESTATES DAM NO.1 M031714

The elevation of the centerline of the crest of the dam varies from 687.9 to 689.0 or approximately 1.1 feet. The low point of the embankment was apparently caused by greater settlement near the area of the greatest height of fill. This area is located towards the left abutment near the site of the original creek bed. A profile of the crest of the dam is shown on Exhibit 3 of Appendix B.
